Anacostia Trash TMDL-Related Baseline Conditions Monitoring (June 2008 - July 2009)

Metropolitan Washington Council of Governments,
Department of Environmental Programs

Montgomery County
Department of Environmental Protection
and
Prince George's County
Department of Environmental Resources

October 23, 2009

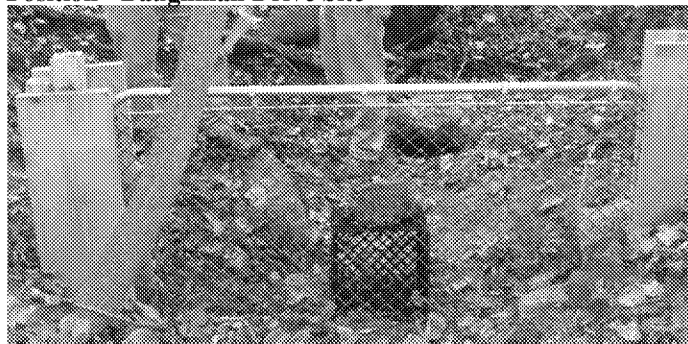
Figure 3 - Trash Fence With Sub-Sampler In The Closed Position - Baughman Drive Site

pass through the trash fence without either completely destroying the chain link fencing and/or support posts, or causing flooding-related problems. This break-away system employed 75 pound tensile strength, electrical plastic ties secured along both the bottom and sides of the fence. Under high water pressure, the ties snapped allowing the chain link panel to swivel upwards without being damaged. Complementing this breakaway feature was an additional stone-lined or sand-bagged overflow area (for safely bypassing high stormwater flows around the sides of the fences without either damaging them or creating localized erosion problems).

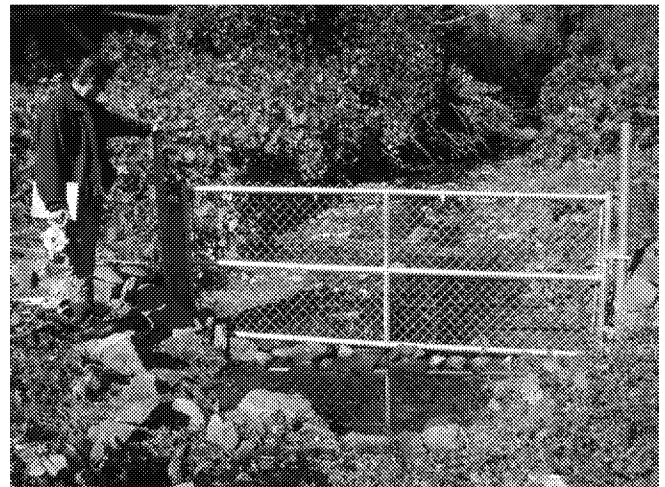
Figure 6 - Trash Fence With Hinged Gate

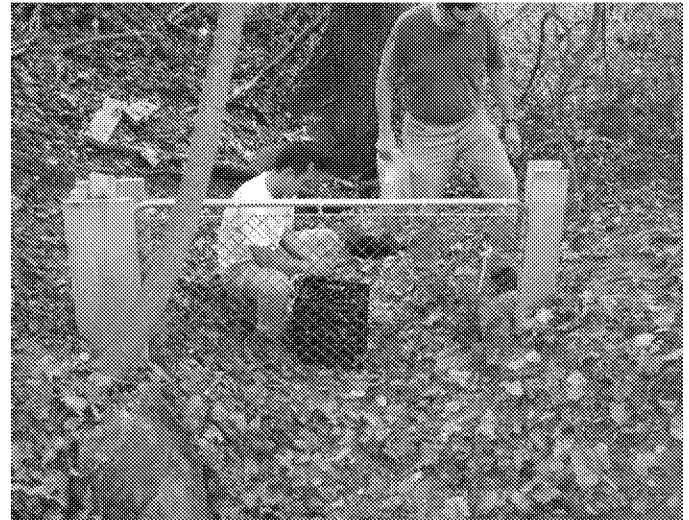
Figure 7 - Installing the Baughman Drive Fence

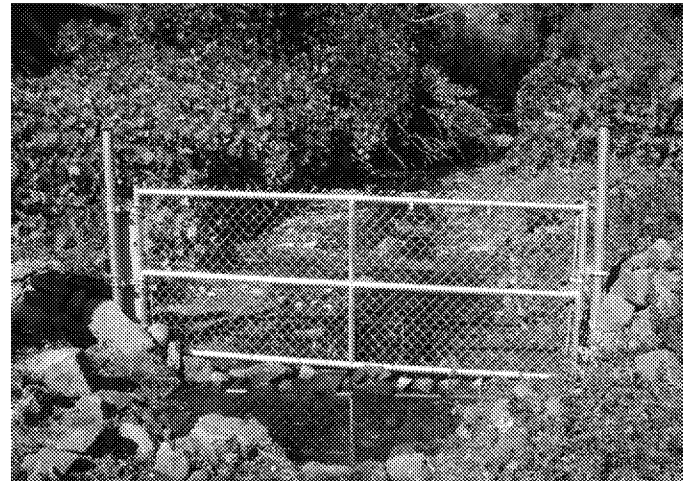
Figure 8 - Raydale Road Gate in Closed Position

A custom fabricated, heavy duty swinging steel gate was employed at this site (Figure 8). The single, hinged gate panel was attached to heavy gauge steel posts located along the bottom edge of the channel. Large boulder-sized stones were employed along the bottom and sides of the trash fence to fill the voids spaces and to armor the sides of the drainage channel.

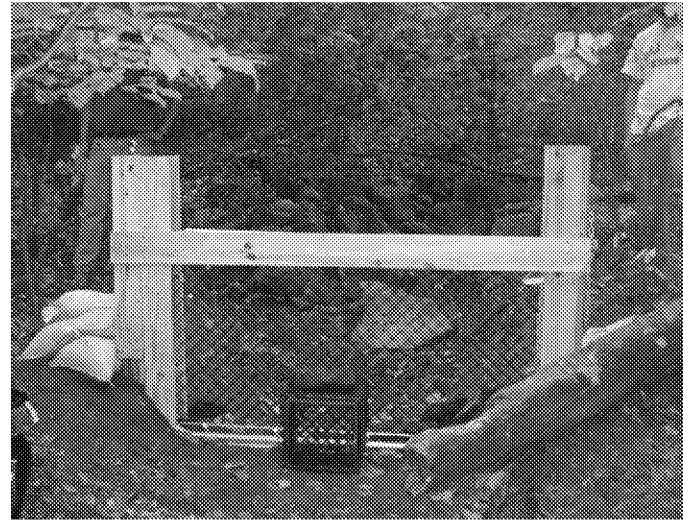
Figure 9 - Silver Spruce Trash Fence

The trash fence design employed at this site was the removable trash fence panel. It featured two, four-inch by four-inch slotted support posts augured into the sides of the outfall channel. A six foot by three foot aluminum chain link fence panel was inserted in between the posts, flush with the bottom of the channel. Down slope of the trash fence, stormwater flows (through an open gully/channel) for approximately 100 feet before entering the Silverwood Tributary, a feeder stream to the Little Paint Branch.

The Silver Spruce trash fence is located within the Little Paint Branch subwatershed in Montgomery County. The fence is located on M-NCPPC park property directly behind the Silver Spruce Circle Town Homes development. The site drains an area comprised of medium density town houses and associated parking lots. The drainage area is approximately 2.3 acres, of which approximately 0.7 acres are parking lots and roadway areas. The site has one storm drain inlet and a 21-inch RCP outfall, which discharges into a small earthen channel. The trash fence is located approximately 30 feet downslope of the outfall (Figure 9).

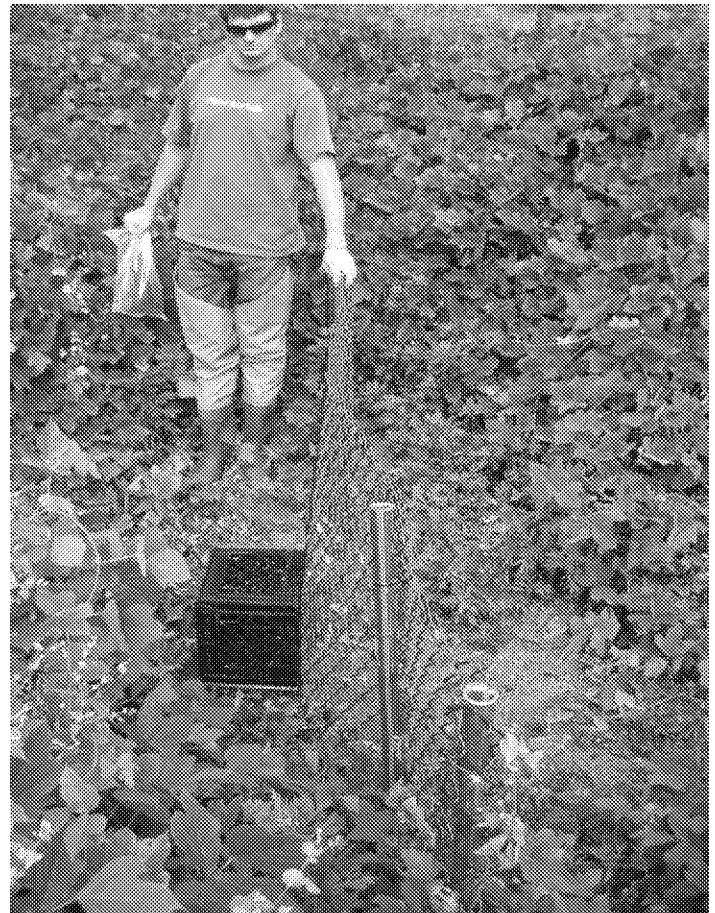
Figure 10 - Kirkwood Apartments Trash Fence and Kudzu

The Kirkwood Apartments trash fence is located within the Northwest Branch subwatershed in Prince George's County. The fence is located on M-NCPPC park property, but drains an adjacent area made up of high density garden apartments (Kirkwood Apartments). The drainage area totals approximately three acres, of which approximately one acre is associated with road and parking lots. The site has five storm drain inlets and a 24 inch RCP outfall which discharges into an earthen drainage ditch. The trash fence is located approximately 30 feet downslope of the outfall.

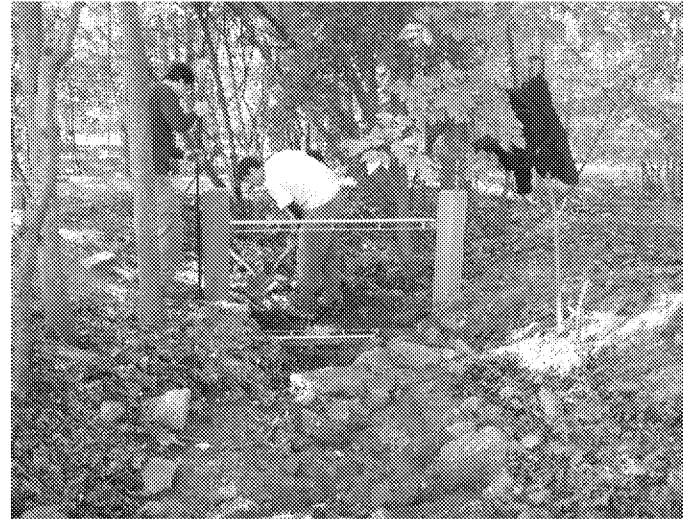
Figure 11 - Installing the Kemp Mill Fence

The trash fence design employed at this site was the removable trash fence panel. It featured two, four-inch by four-inch slotted support posts augured into the sides of the outfall channel. A six foot by three foot aluminum chain link fence panel was inserted in between the posts, flush with the bottom of the channel. Downslope of the fence is an approximately 400-foot long drainage channel that discharges into Sligo Creek.

The Kemp Mill Shopping Center trash fence (SC-SD1) is located within the Sligo Creek subwatershed in Montgomery County. The fence is located on M-NCPPC's Sligo Creek Park property (Figure 11), but drains a commercial area (mainly consisting of a parking lot for the Kemp Mill Shopping Center). The drainage area totals approximately 4.2 acres, of which 3.3 acres are parking lot and roadway areas. The site has one storm drain inlet and a 27-inch RCP outfall, which discharges into an earthen and rock-lined channel.

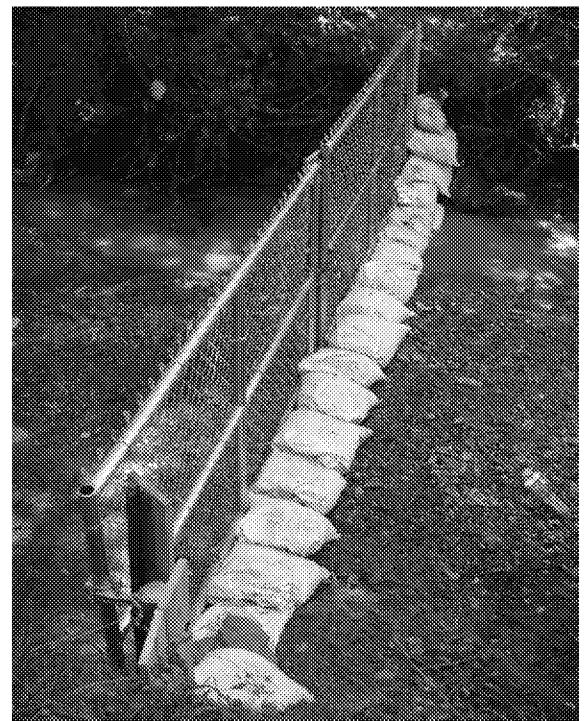
Figure 12 - Beltsville Industrial Park Trash Fence

The Beltsville Industrial Park trash fence (IC-SD1) is located within the Indian Creek subwatershed in Prince George's County. The fence sits on USDA-BARC property adjacent to the CSX Capitol subdivision railroad tracks. It drains an area of predominantly industrial and commercial land uses (i.e., the Beltsville Industrial Park). The associated drainage area is approximately 226 acres, of which approximately 66.5 acres are roads and parking lots. The site has approximately 68 storm drain inlets and a drainage network that terminates into an unnamed intermittent tributary of Indian Creek via a 48-inch box culvert. The trash fence was located 25 feet downstream of the culvert.

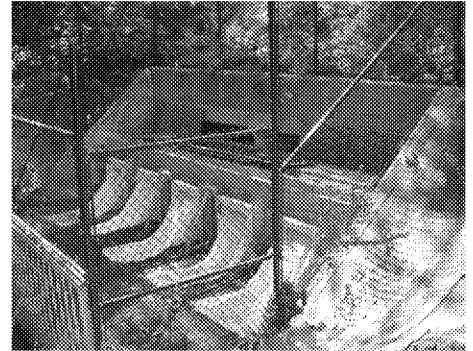
Figure 13 - Takoma Branch Fresh Creek Netting Trashtrap® System, Fall 2007

The upstream drainage area is approximately 659 acres. It is primarily made up of medium density single family residential and garden apartment buildings, as well as some commercial land use areas. The medium density, single family residential land use areas are located within all three jurisdictional portions of the catchment (i.e., Prince George's County, the District of Columbia and Montgomery County). The netting system installation was completed in October 2007 (Figure 13). As of the first week of June 2009, the system was taken off-line because of structural failure resulting from a week of high stormflows.

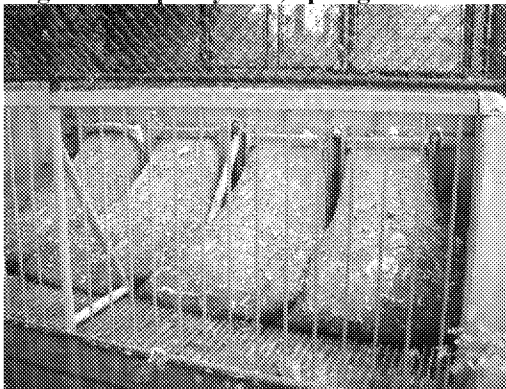
Figure 14 - Lower Beaverdam Creek Fresh Creek Netting Trashtrap® System, Spring 2009

The Lower Beaverdam Creek Trashtrap (LBC-TN) is located within the Lower Beaverdam Creek watershed in Prince George's County. The trash trap is physically located in M-NCPPC's Kentlands Park near the intersection of Flagstaff Street and Columbia Place. It consists of a set of four removable 0.5 inch diameter opening fabric mesh nets that are attached to a ridged metal face plate (Figure 14). The entire system is also surrounded by a chain link fence designed to prevent vandalism and/or injury.

The netting system serves a 40.8 acre drainage area that is primarily made up of high density residential garden apartments and medium density residential single family homes. It should be noted that the Kent Village Garden Apartment employs storm drain inlet grates for the majority of their inlets (Figure 15).

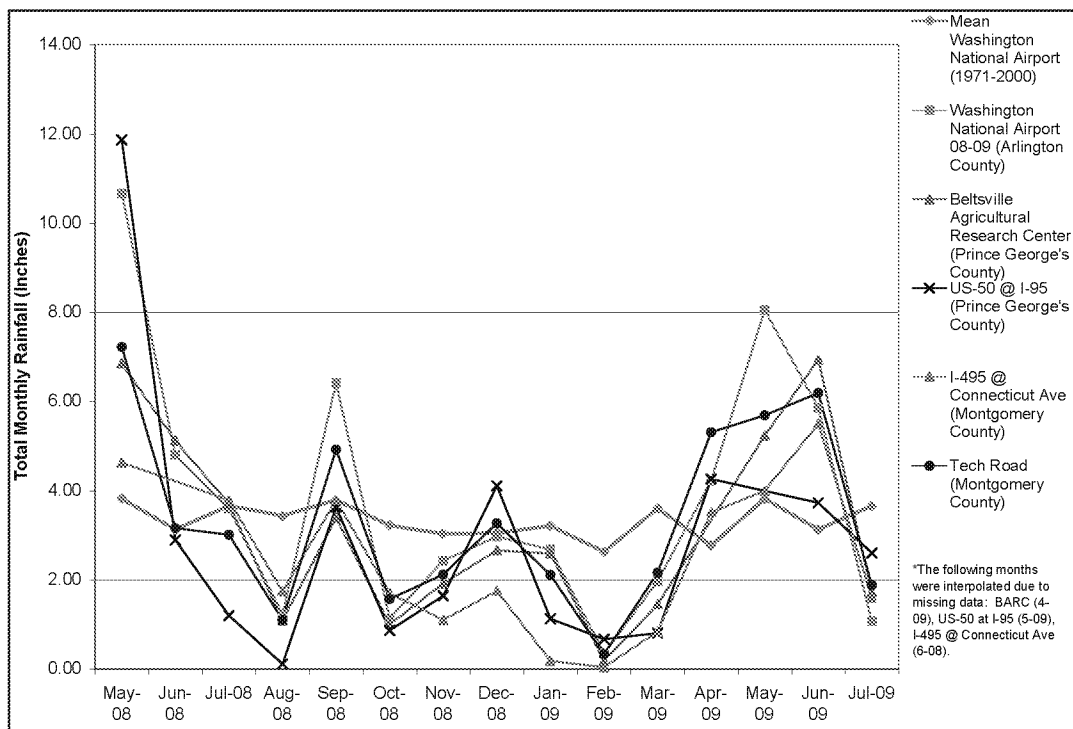
Figure 17 - Monthly Rainfall Data Summary - May 2008 - July 2009

shows DCA with much higher rainfall totals as a result of the more southerly track of the Tropical Storm Hanna. In addition, in May 2009 DCA received over eight inches of rain while the BARC site received only five inches. Even for stations that are only three miles apart, though to a lesser degree, in May 2009 the Tech Road station 3 rainfall total was 0.73 inches more than at BARC station 4. However, in June 2009, the reported rainfall total from the BARC station was 0.75 inches more than for the Tech Road station. Appendix 3 is included for additional rainfall-related data.

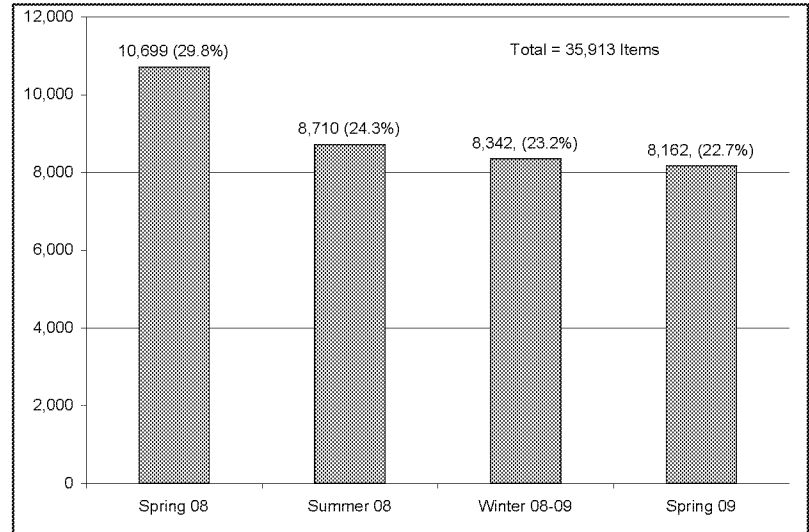
Figure 18 - Stream Summary - Trash Items Counted and Percent of Total

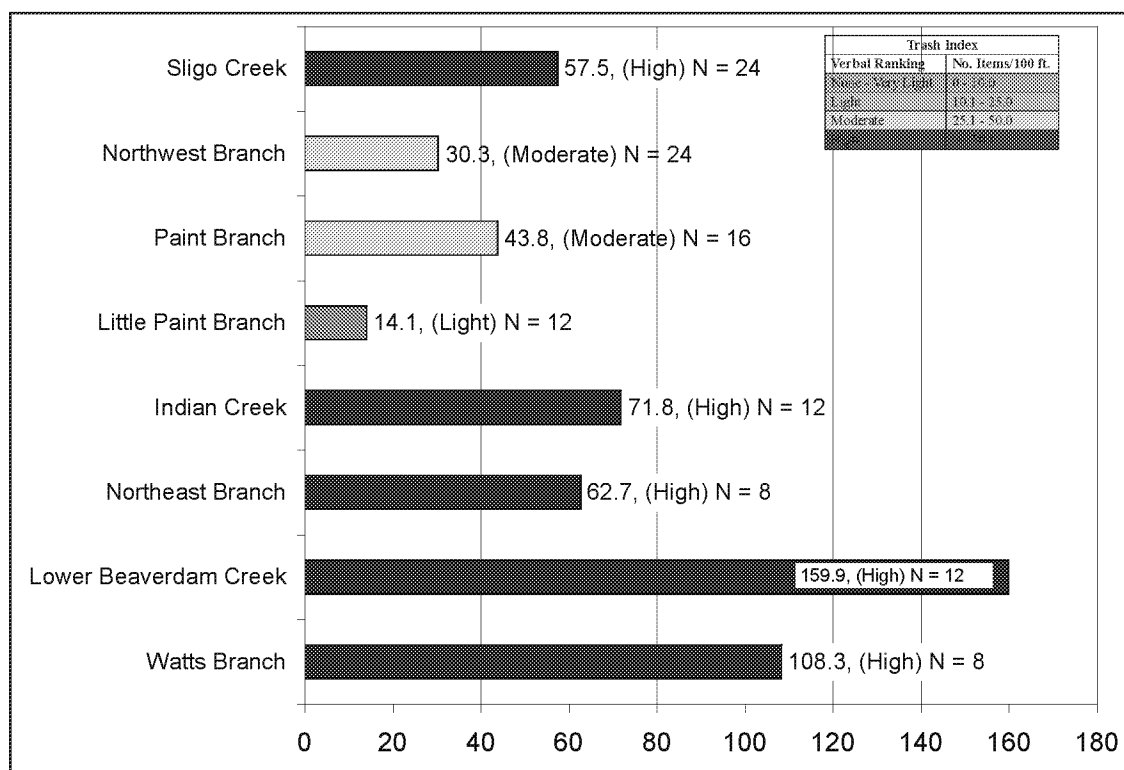
Figure 21 - Stream Subwatershed Summary - Mean Number of Items per 100 Feet

For the eight subwatersheds surveyed, the highest mean number of trash items per 100 feet was observed in Lower Beaverdam Creek (159.9), followed by Watts Branch (108.3), Indian Creek (71.9), Northeast Branch (62.7), Sligo Creek (57.6), Paint Branch (43.8), Northwest Branch (30.3) and Little Paint Branch (14.1) (Figure 21). Table 3 represents the 1998 Anacostia Trash Reduction Workgroup's (ATRW) stream trash survey index, which provides a verbal ranking for the number of trash items per hundred feet range. It should be noted that this index has been in continuous use since 1998. Excluding the Little Paint Branch (which fell into the 'light' category) and both Northwest Branch and Paint Branch (which fell into the 'moderate' category), all the other remaining subwatersheds fell into the 'high' category.

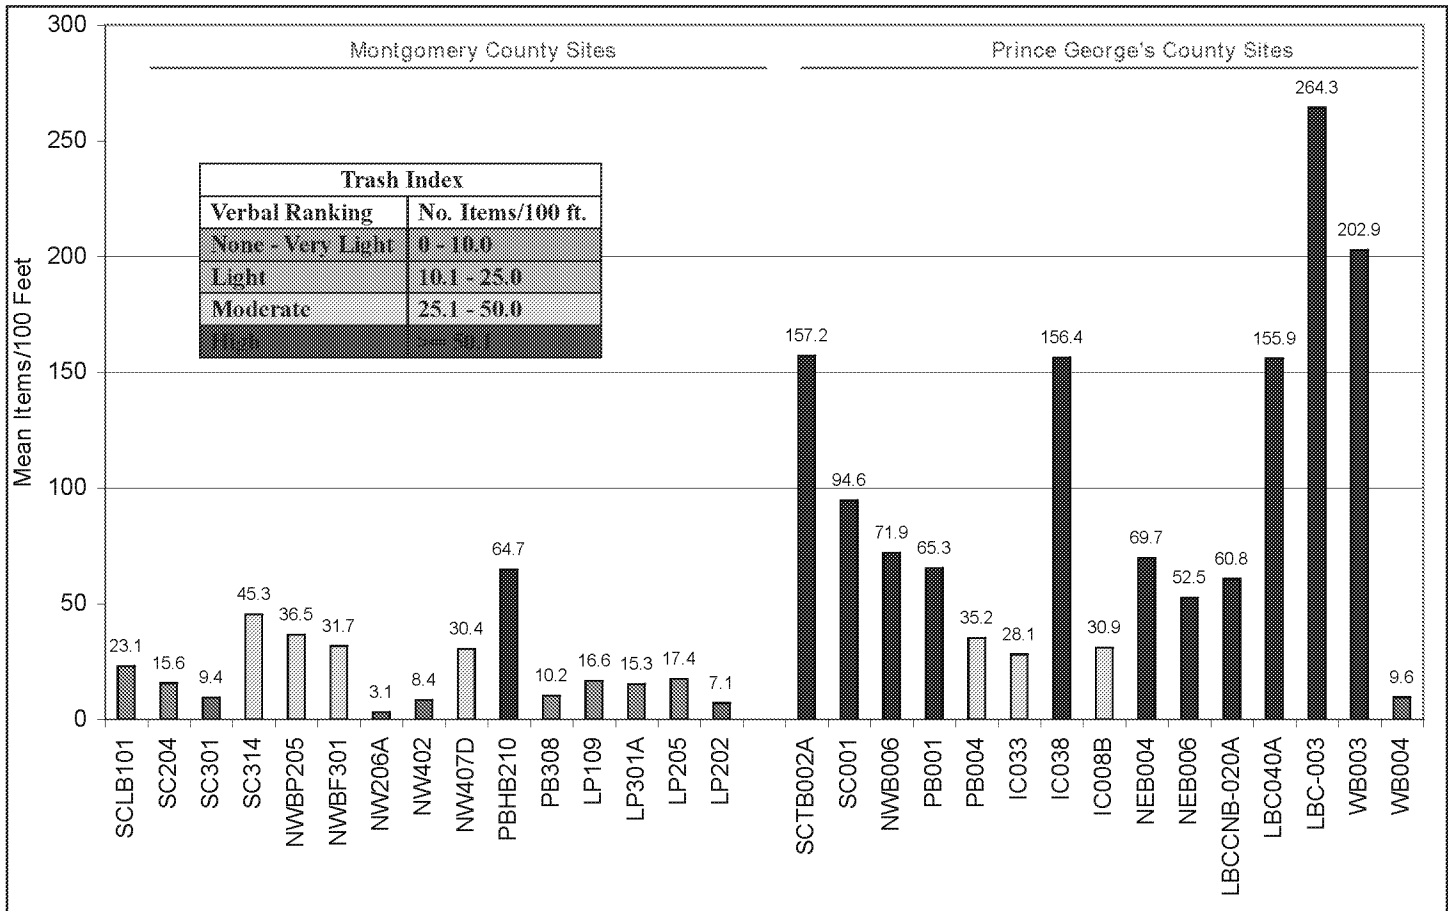
Figure 22- Stream Summary - Mean Number of Items per 100 Feet by Jurisdiction

Table 4 and Figure 22 show the mean number of items per 100 feet over four survey dates for both Montgomery and Prince George's counties. Overall, there were 12 sites with 'high', seven 'moderate', six 'light' and five 'none' - 'very light' rankings. Per jurisdiction, the Montgomery County sites totaled 6,693 trash items or 18.6 percent of the total trash items counted. In contrast, Prince George's

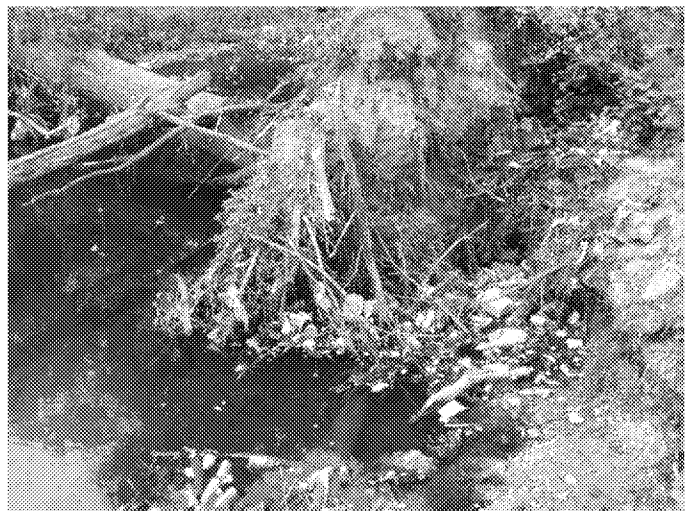
Figure 24 - Trash Strainer - Tree Fall Across The Stream

Included as part of the stream survey, trash ‘strainers’ (i.e., natural or anthropogenic features such as log/debris dams, large protruding tree roots and rootwads, gabion baskets, large appliances, shopping carts, etc.) were also counted. Strainers effectively capture and temporarily retain trash, particularly floatables (Figure 24). During this four survey periods, a total of 873 strainers were observed at the 30 sites, with a mean of approximately 218 strainers per season.

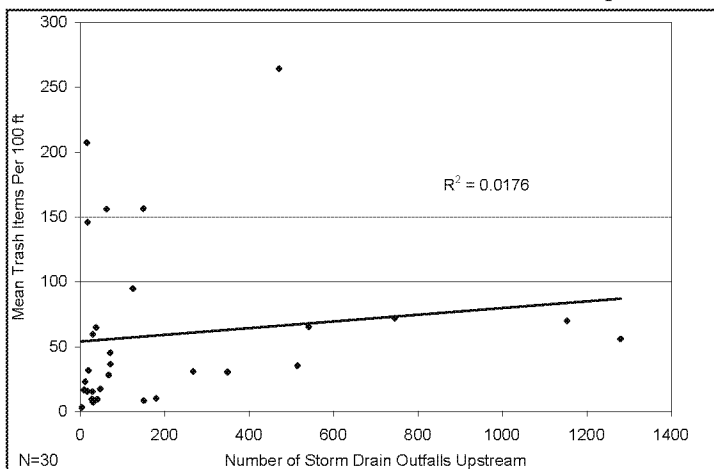
Figure 25 - Mean Number of Trash Items per 100 Feet and Total Number of Storm Drain Outfalls Upstream

However, clear relationships were not observed. Figures 25-28 are selected graphs showing the mean trash items per 100 feet graphed to the number of storm drain outfalls upstream, to the distance (stream survey site) from headwaters, upstream drainage area and mean number of strainers (mean number of strainers over the four seasons surveyed).

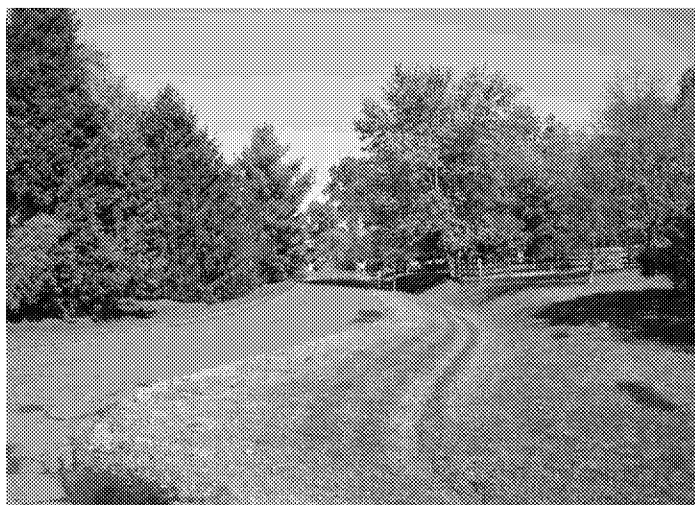
Figure 32 - Baughman Drive Road (NWB-SDR1)

Based on field observations, Baughman Drive is a neighborhood access road that receives light traffic. Even lighter traffic was observed on Baughman Court, a road that provides direct access to a total of three homes. During the entire survey period, the local neighborhood area, including road right-of-way areas, was always extremely well kept.

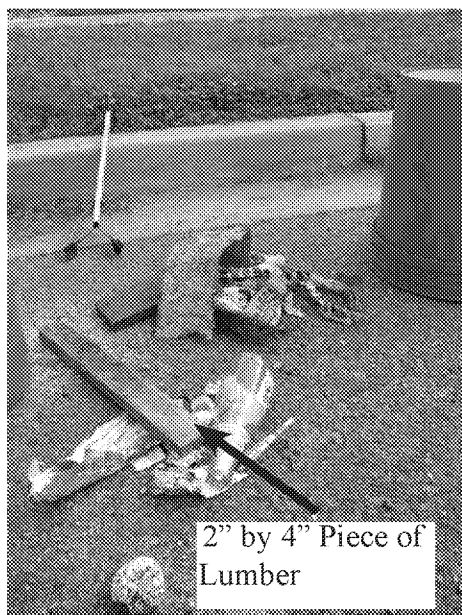
Figure 38 - Raydale Road - May 22, 2009 Survey Trash Items

The weight of all the trash items collected at the Raydale Road site totaled 5.1 pounds. This was the second highest weight total among all six sites. Of the top six items by weight, construction debris, at 1.97 pounds, accounted for 38.6 percent of the total weight (Figure 37). Construction debris generally included short sections of 2 by 4 inch lumber (Figure 38). Paper, food packaging, glass bottles plastic bottles and miscellaneous items, from highest to lowest, rounded out the remainder of the top six categories and their percent of the total weight was 20.4, 9.1, 8.7, 7.7 and 7.7, respectively.

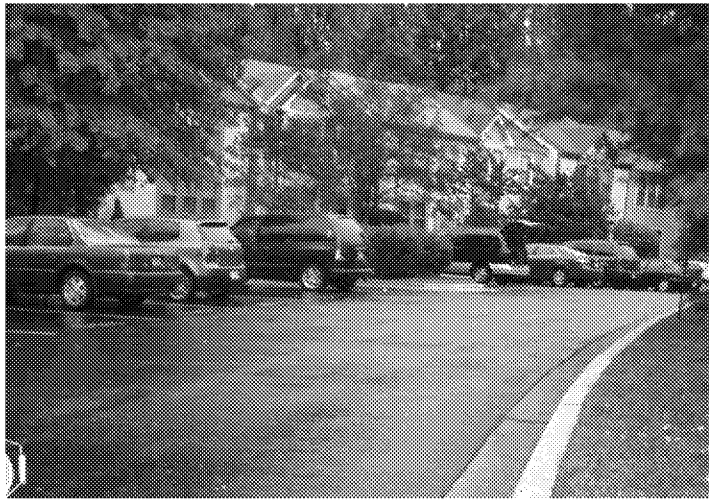
Figure 39 - Silver Spruce Townhouses (LPB-SDR1)

This survey site represents medium density, residential townhouse land uses in the Little Paint Branch subwatershed in Montgomery County (Figure 39). The number of trash items counted for the survey period totaled 107. Of the top six items counted, paper (39.3 percent), food packaging (23.4 percent), and miscellaneous items (17.8 percent) were the top three, respectively. Cardboard (4.7 percent) plastic bags (3.7 percent) and construction debris (2.8 percent) were the remaining three items of the top six trash items collected (Figure 40). Based on the ATRW trash index, trash levels were in the 'light' range (i.e., 10.1 - 25.0 items).

During the survey, tissue paper and paper napkins were frequently observed along curb area. In addition, both middle and high school-aged children were frequently observed playing in the parking lot areas.

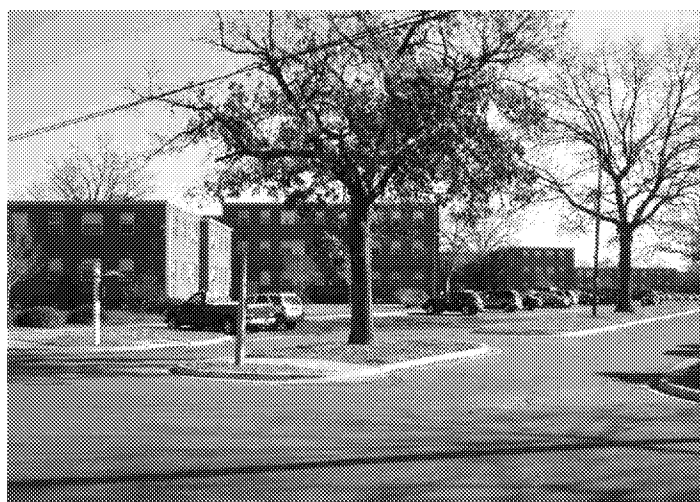
Figure 42 - Kirkwood Apartments (NWB-SDR2)

The Kirkwood Apartments site is representative of high density residential garden apartment land uses present in the Lower Northwest Branch subwatershed in Prince George's County (Figure 42). The number of trash items counted for the survey period totaled 115. Of the top six items by count, paper, miscellaneous items, and food packaging were the top three trash items, and accounted for 39.1, 21.7, and 17.4 percents of the total items, respectively. Aluminum cans, plastic bottles and plastic bags, were the next three items and their percent of the total trash items, by count, were 11.8, 5.9 and 5.1 percent, respectively (Figure 43). Based on the ATRW trash index, trash levels were in the 'light' range (i.e., 10.1 - 25.0).

During the survey, it was observed that Kirkwood Apartments maintenance facility staff conduct daily roadside and parking lot trash pickups on apartment property (i.e., along both Nicholson Lane and Mall Road). This strongly suggests that the litter problem here is higher than what is supported by the data. In addition, along the Nicholson Lane road right-of-way, M-NCPPC staff was observed conducting similar but weekly trash removal. This further suggests that this area has been identified as a high litter problem area.

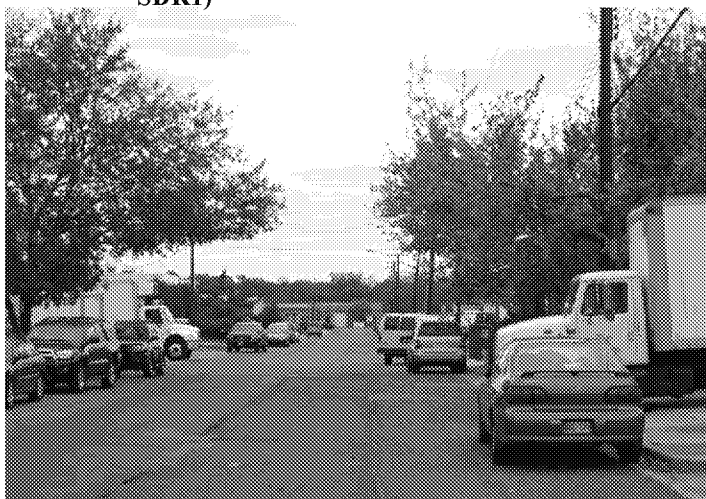
Figure 48 - Beltsville Industrial Park - (Hanna Street) (IC-SDR1)

The Beltsville Industrial Park site is representative of industrial land uses present in the Upper Indian Creek subwatershed in Prince George's County (Figure 48). The number of trash items counted for the survey period totaled 497, a survey high. Of the top six items counted, miscellaneous items (26.4 percent), food packaging (18.5 percent), and paper (17.3 percent) were the top three items. Plastic bottles (12.9 percent) and aluminum cans (6.2 percent), and metal items (4.4 percent) were the remaining three items that comprised the top six (Figure 49). Based on the ATRW trash index, trash levels were in the 'high' range (i.e., > 50.1 items).

Within the Beltsville Industrial Park area, there appears to be little or no trash/litter removal along the road right-of-ways. It is also apparent that many of the property owners show very little interest in maintaining trash/litter free facilities. Furthermore, Ewing and Tucker roads are major delivery routes and are recipients of trash discarded from passing vehicles. Currently, there is no adopt-a-road program for this industrial park area.

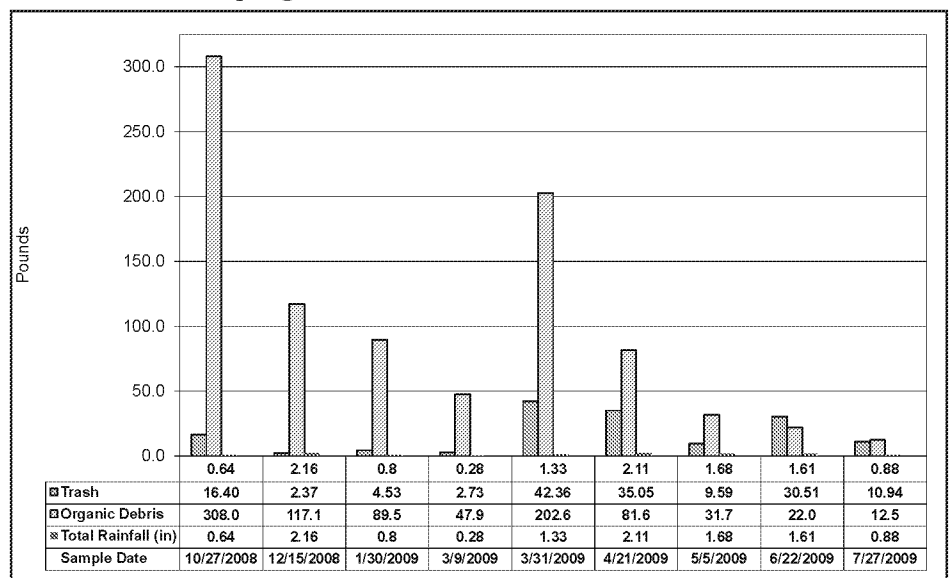
Figure 51 - Summary - Storm Drain Trash and Organic Debris Loads per Sampling Date

2009) to the spring and summer months (i.e., March - July 2009). As expected, the organic debris levels tended to slowly decrease after the fall season (i.e., October - December 2008, leaf-fall period). However, an increase in both trash and organic debris levels was observed for the March 31 2009 sample. This is attributable to multiple factors including both higher precipitation and rainfall intensity levels.

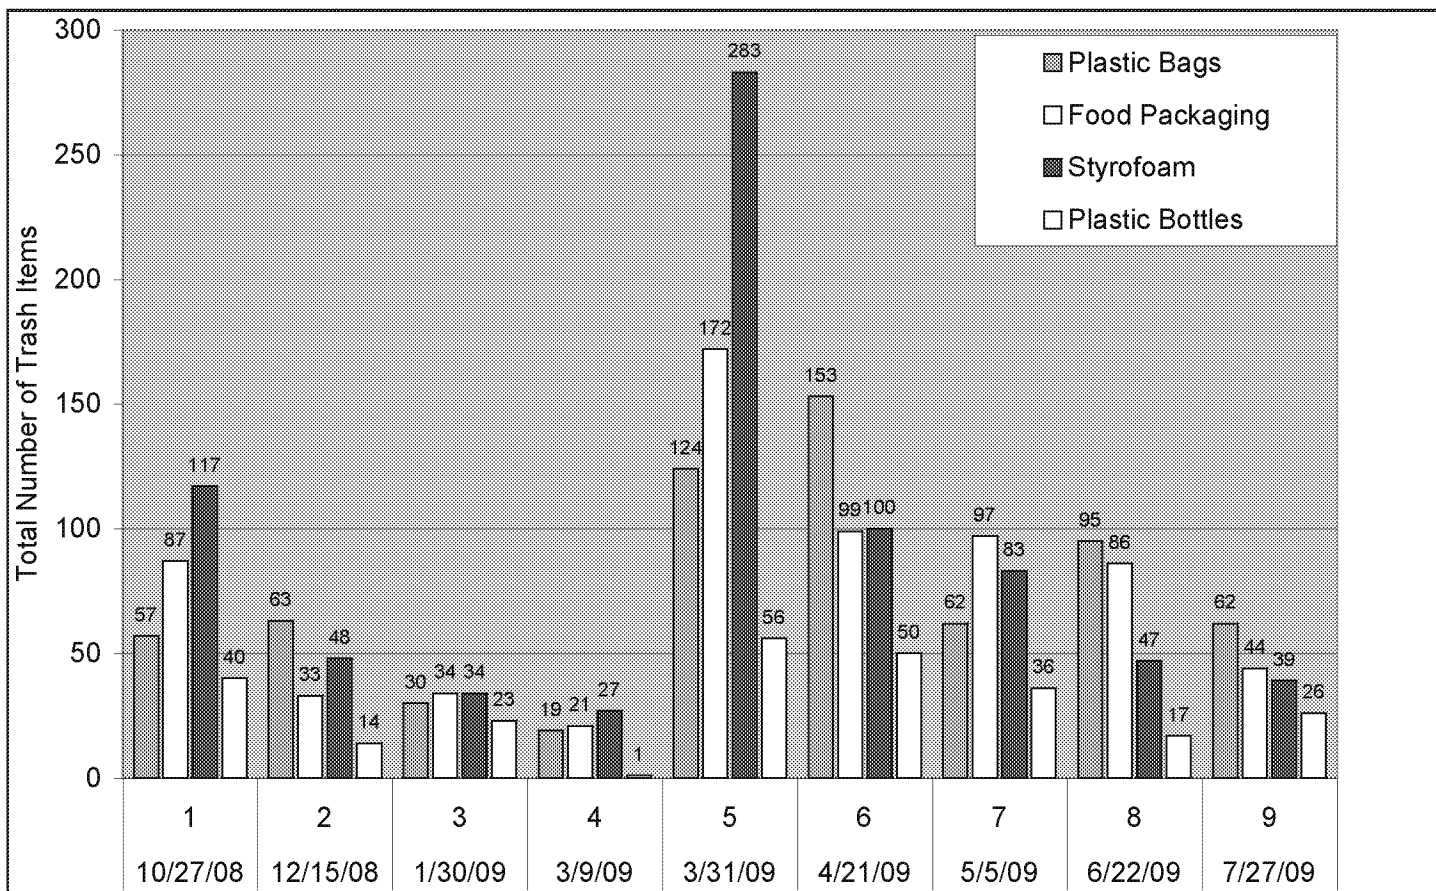
Figure 52 - Selected Floatable Trash Items per Sample Date By Count

Four selected floatable trash items (i.e., plastic bags, food packaging, Styrofoam and plastic bottles) totaled 2,379 and accounted for over 82 percent of the total trash items counted. These floatable items are shown for each survey sampling date in Figure 52. Importantly, the quantity of the four trash items increased from March 31, 2009 through July 27, 2009. During this period, the count for these four items totaled 2,104 or 72 percent of the total. Similar conditions were observed for the spring 2008 and summer 2009 stream survey data, as total trash counts were both greater than those for winter 2009. It is expected that with normal rainfall patterns during the warmer months of the year, that trash levels increase in both the storm drain outfall and stream areas. For additional storm drain outfall data, the reader is referred to Appendix 5.

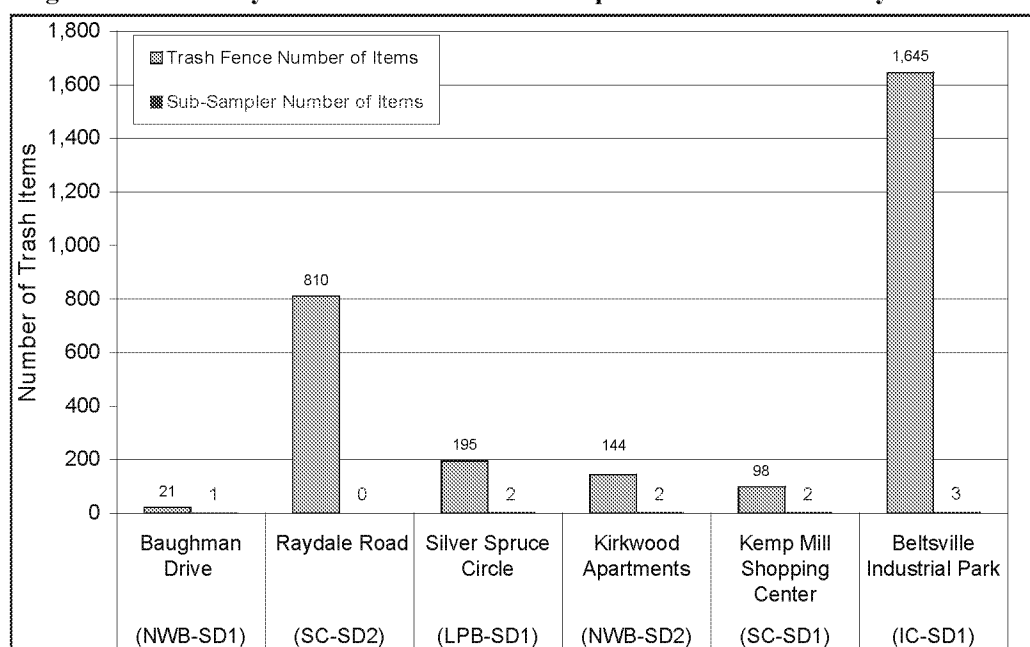
Figure 53 - Summary - Trash Fence and “Sub-sampler” Number of Items by Count

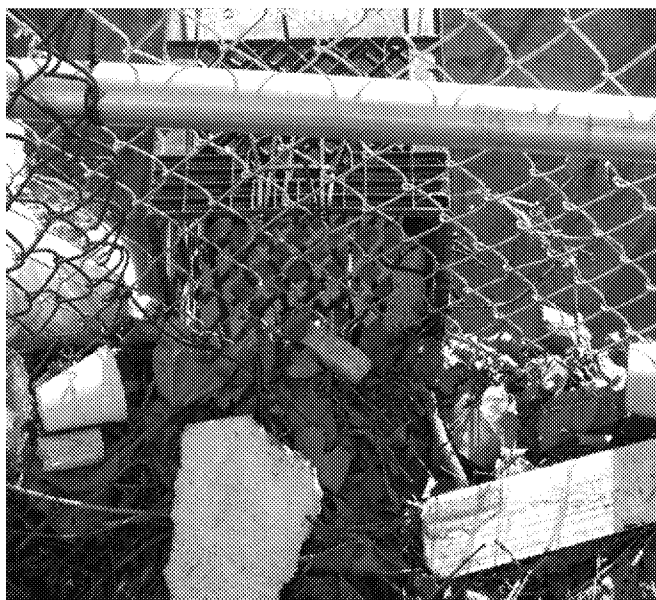
Figure 54 - Sub-Sampler Captures a Styrofoam ‘Peanut’

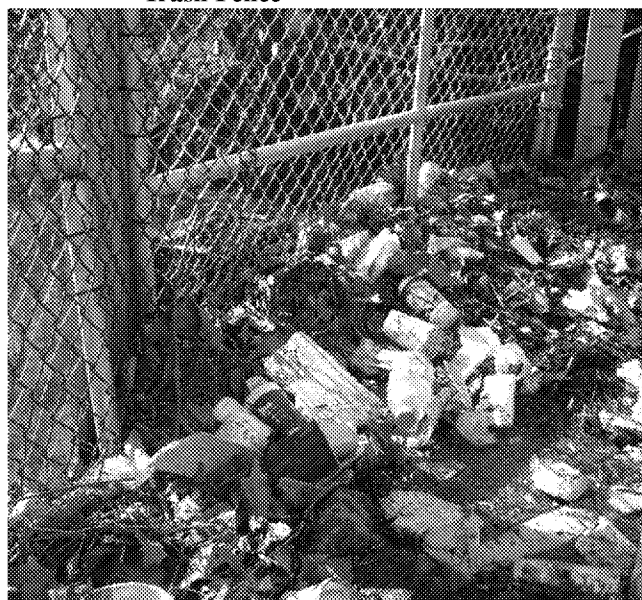
Figure 55 - Trash and Debris Accumulation on the Trash Fence

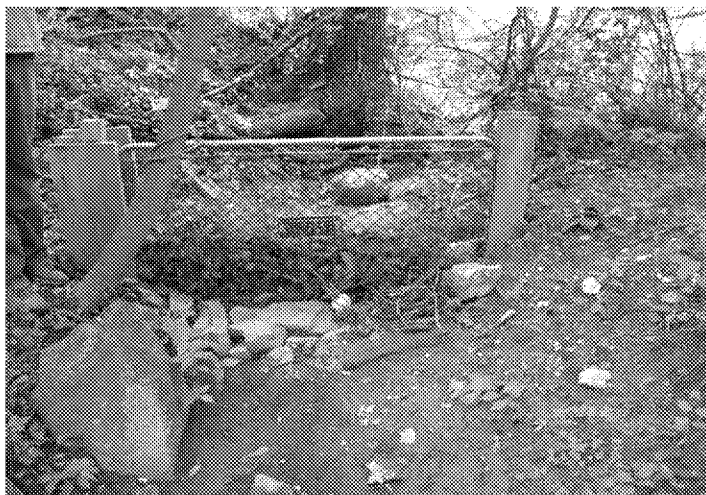
Figure 56 - Baughman Drive Trash Fence

As previously mentioned in the road survey section, the Baughman Drive neighborhood is extremely well-kept.

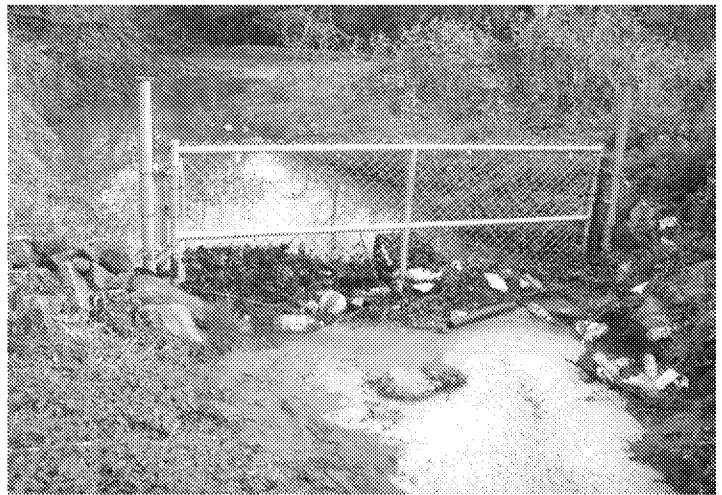
Figure 59 - Raydale Road Trash Fence

‘Windshield’ surveys performed by COG staff during the study for the surrounding Chillum-Ray neighborhood revealed that the side road areas (above Redtop Road) in this single family residential area were relatively trash free. However, trash levels along portions of Riggs, Ray and Raydale Roads were in the light to high range; strongly suggesting that these road areas contribute the major portion of the trash load delivered to the Raydale Road storm drain system. It should be noted that Riggs Road is a major arterial road with both institutional and fast food commercial land use areas, and that Ridgecrest Elementary School is also located at the intersection of Ray and Riggs Roads. Based on a 1999 COG Riggs Road trash survey, trash levels there were rated as being high (i.e., > 50 items per 100 feet). Current conditions appear to have remained relatively unchanged. Ray Road is a ma-

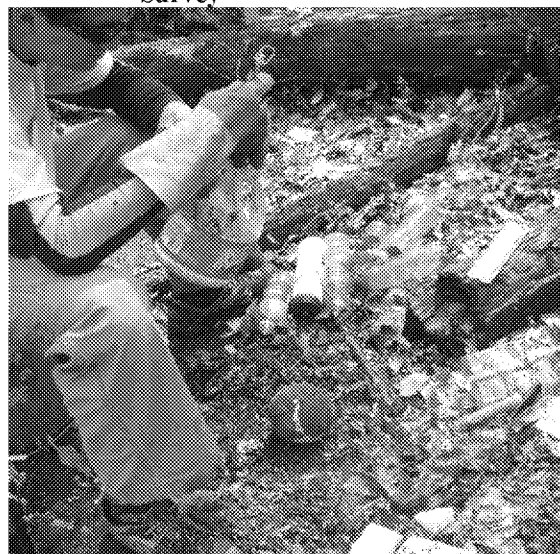
Figure 62 - Silver Spruce April 2009 Trash Survey

As previously noted, during the survey period it was observed that middle and high school-aged children were frequently playing in the townhouse parking lot areas.

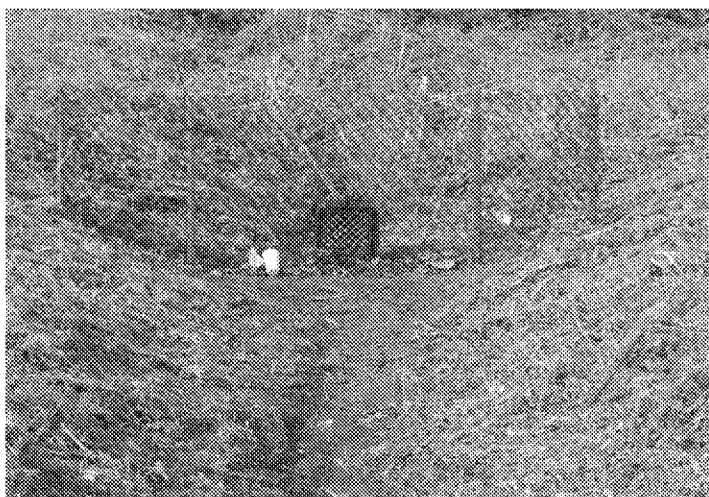
Figure 65 - Kirkwood Apartment Trash Fence

As previously indicated in the road survey portion of the study, it was observed that Kirkwood Apartments maintenance facility staff perform daily road and parking lot litter patrol/trash cleanups on apartment property (i.e., along both Nicholson Lane and Mall Road). Similarly, along the Nicholson Lane road right-of-way, M-NCPPC conducts weekly trash cleanups. The preceding observations suggest that the actual amount of trash generated from this land use type may in fact be higher than what the monitoring results for both the storm drain outfall and road/parking lot surveys indicate.

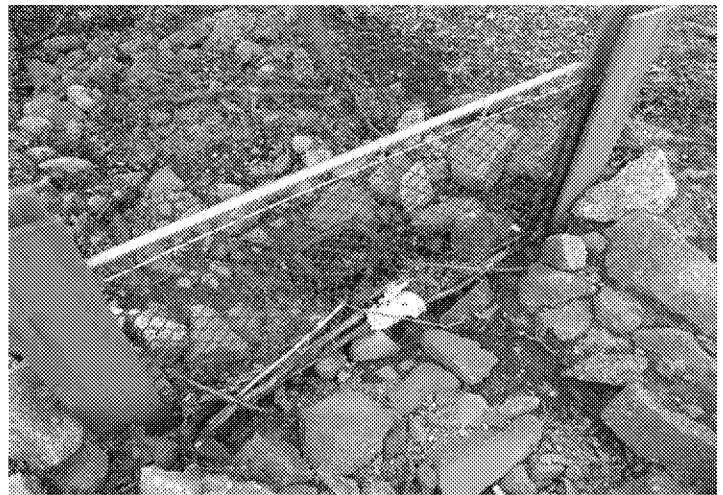
Figure 68 - Kemp Mill Shopping Center Trash Fence

The Kemp Mill Shopping Center storm drainage area is approximately 4.2 acres. During the study, a total of 98 trash items weighing 1.5 pounds were collected there (i.e., the lowest trash level among the six storm drain outfall sites). The calculated trash pound per acre ratio was 0.4:1. It should be noted that for this relatively small drainage area, a smaller removable trash fence was also employed (Figure 68).

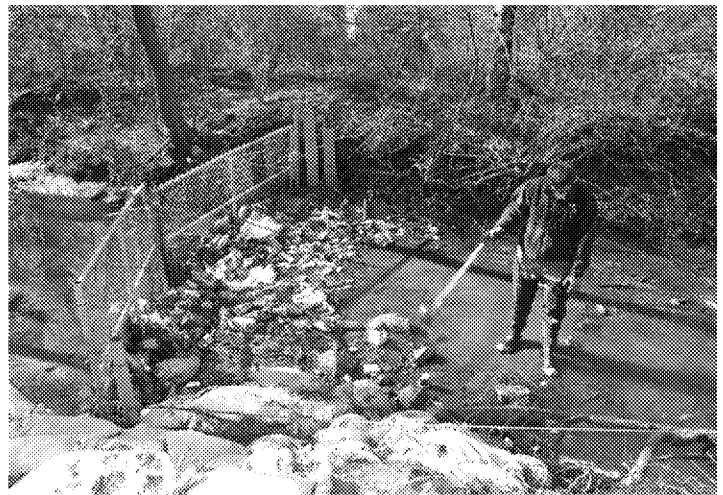
Figure 71 - Beltsville Industrial Park Trash Fence

Among the six trash fence sites, the Beltsville Industrial Park site had, at 226 acres, the largest associated drainage area. It is a mixed land use area but the predominant land use is industrial/commercial, which comprises approximately 57 percent of the total area. As previously mentioned, this trash fence featured two, large eight foot-long hinged gates, with two-inch diameter breakaway chain link fencing (Figure 71). This design took into account the frequent high intensity storm flows present at the site.

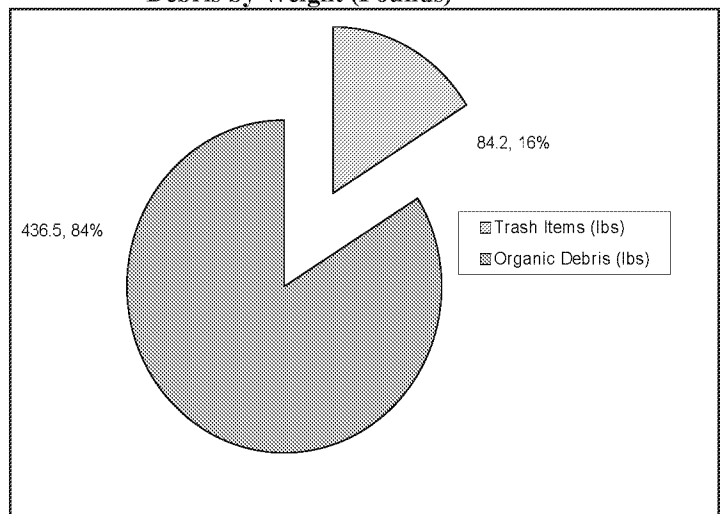
Figure 73 - Beltsville Industrial Park - Trash and Organic Debris by Weight (Pounds)

The top six items by count, from highest to lowest, were Styrofoam, plastic bags, food packaging, plastic bottles, aluminum cans and miscellaneous items. It should be noted that Styrofoam (e.g., packing peanuts, sheets, blocks and spacers) and plastic bags (i.e., bulk packaging and shrink wrap) were generally related to manufacture packaging. As seen in Figure 72, the top six items by weight were in descending order plastic bags (35.9 percent), Styrofoam (14.7 percent), plastic bottles (12.1 percent), food packaging (10.6 percent), construction debris (8.5 percent) and aluminum cans (5.3 percent). The leafy organic material weight collected at this site totaled 436.5 pounds. This represented 84 percent of the total weight (Figure 73). The ratio of organic material to trash, by weight, was 5:1.

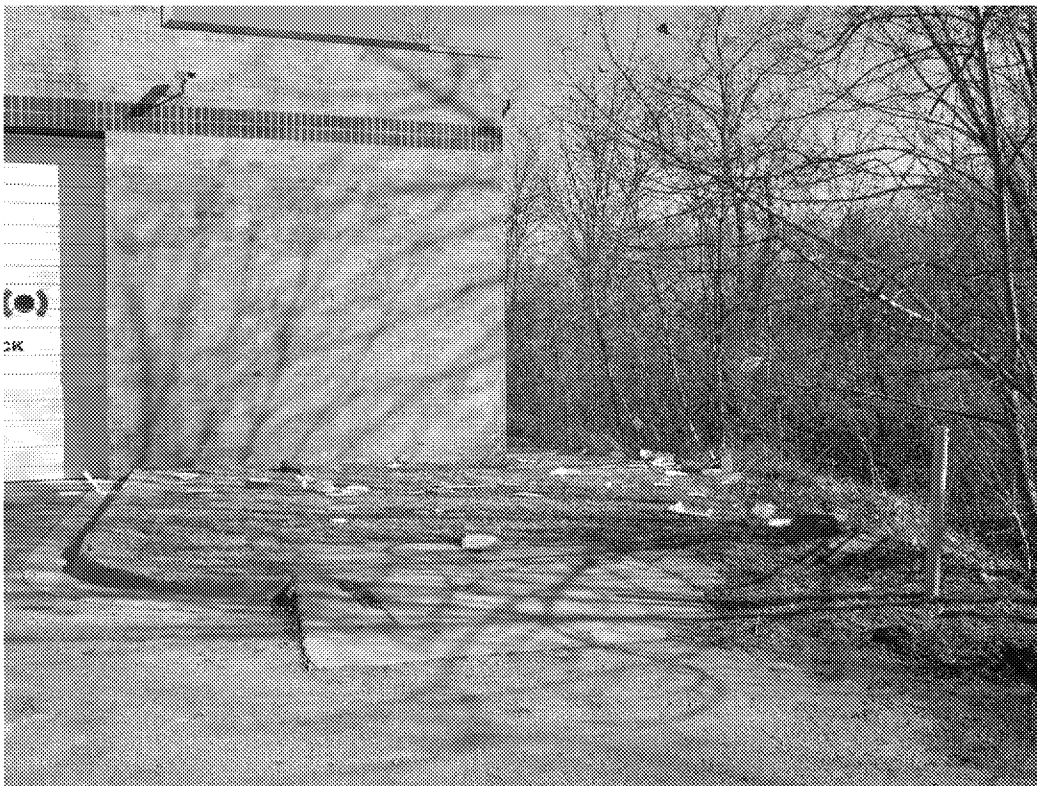
Figure 74 - Beltsville Industrial Park - Hanna Street Private Business Area

As previously noted, the road right-of-ways and many of the businesses within the Beltsville Industrial Park area are not well-kept (Figure 74), and there does not appear to be an adopt-a-road program for this area.

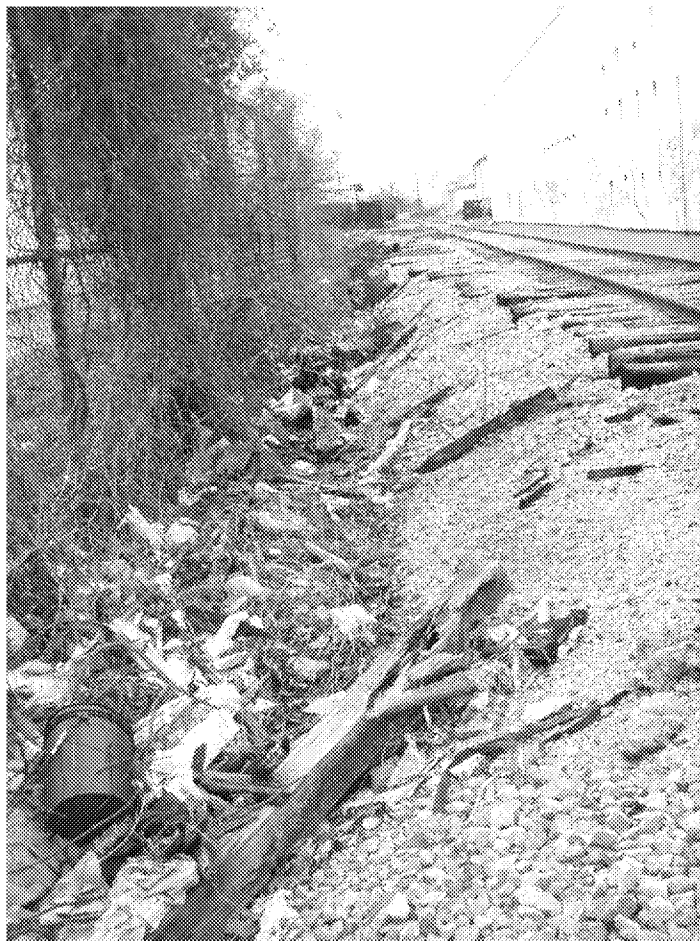
**Figure 75 - Beltsville Industrial Park - Trash and Debris
along the CSX Spur Railroad Area**

It should be noted that there are two short sections of railroad tracks within the drainage area, the CSX Camden Station rail line and a spur from that line that provides access to the Duron Paint Company property. The trash levels along both of these rail lines are extremely high (Figure 75).
